PHOTOGRAPHIC INTERPRETATION REPORT

TACHIU ELECTRONIC
INTERCEPT FACILITY
CHINA

NPIC/R-130/68

JANUARY 1969

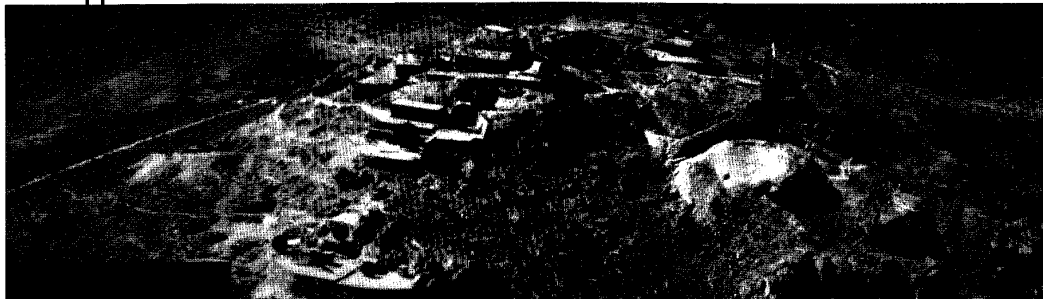
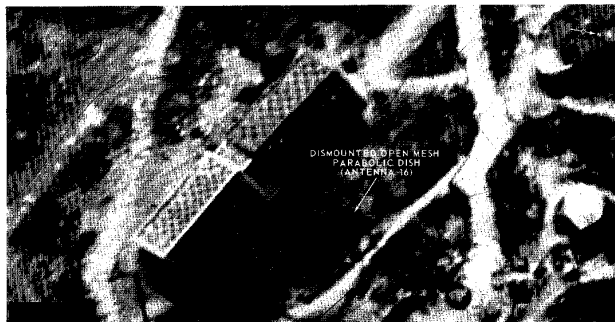
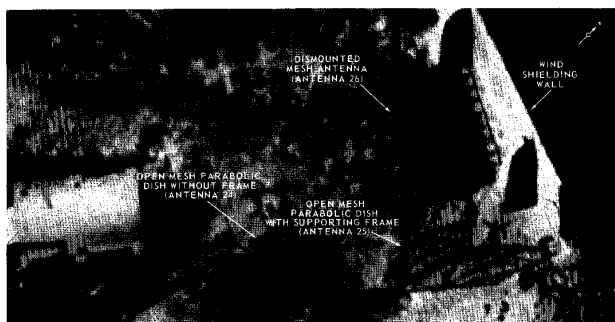
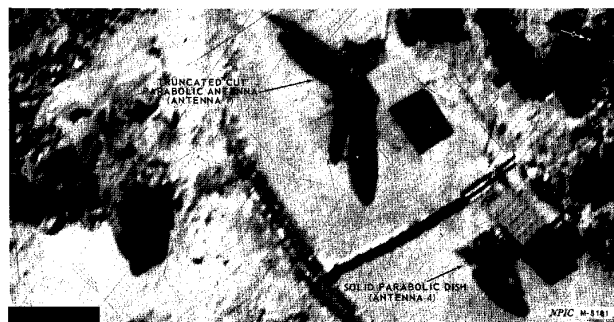
FIGURE 3. ANTENNAS AT TACHILI ELECTRONIC INTERCEPT FACILITY.

One of the seven solid parabolic dish antennas is mounted on a possibly steerable mount while the remaining six are mounted at fixed azimuths. Feed elements on six of the antennas could not be observed. The one visible feed (Antenna 41, Figure 4 and Table 1) appears as a bulbous projection in front of the dish. It appears to be mounted in the center of the antenna; however, the method of attachment could not be determined. [REDACTED]

25X1B [REDACTED] Of the six mesh parabolic dish antennas, two are dismantled while the remaining four are mounted at fixed azimuths. One of the dismantled antennas (Antenna 22, Figure 4 and Table 1) is lying on its face in front of a fixed-azimuth mount. No feed is present. The position of the antenna indicates that it is either under construction, undergoing modification, or being removed; available coverage does not permit a determination of which of these is the case. The second dismantled antenna (Antenna 16, Figure 4 and Table 1) has no mount in its vicinity and its status is undetermined. Feed element detail and mensuration could not be accomplished. All of the open mesh antennas are encased in square supporting frames, except for Antenna 24 (Figure 2 and 3) which is self-supporting. No discernible difference exists in the construction details between the antennas with supporting frames and the one without a supporting frame.
